# 4D-100/200/600/700 2 ½-10"

### IV. CHECK VALVE MAINTENANCE

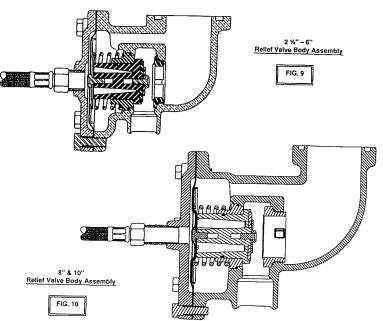
- For all sizes (2 ½" 10"): Disconnect the flexible hose from the RV cover by unscrewing the swivel nut. Remove (2) screws and remove relief valve body assembly.
- 2. Remove cover screws, cover, and diaphragm.
- Remove relief valve cartridge assembly. The unit pulls straight out.
- Remove diaphragm plate retaining screws, and seat disc retaining screws.
- Inspect seat disc, diaphragm, and O-rings for damage. Damaged seat disc may be turned over, but should be replaced as soon as possible. Replace damaged O-rings or diaphragm.

- The RV seat is replaceable, but normally does not need to be removed from the RV body. Inspect the RV seat sealing surface for defects. Replace if necessary with a new o-ring.
- 8. Insert relief valve cartridge into body.
- 9. Replace diaphragm, cover, and cover screws.
- 10. Replace flexible hose.
