993/993RPDA

Servicing First and Second Checks

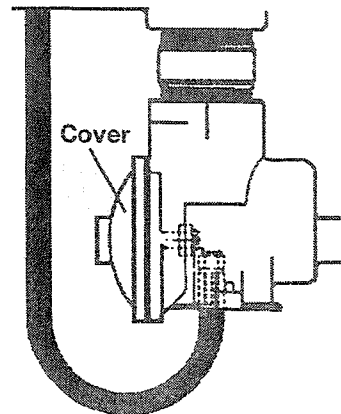
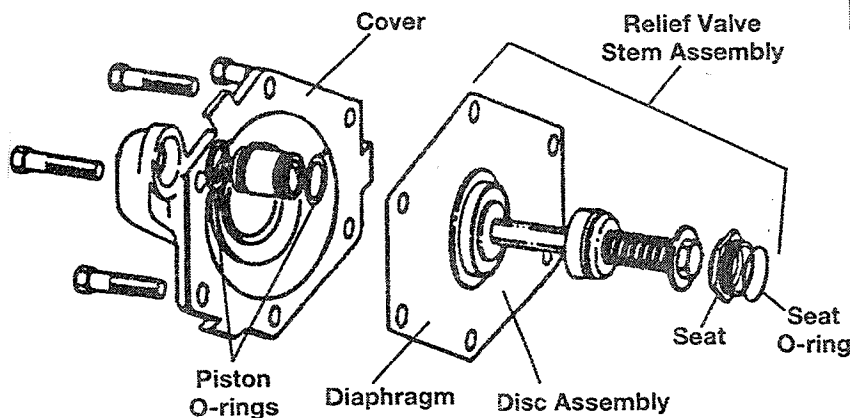
Servicing the Relief Valve

1. Remove sensing hose. Check for debris.
2. Remove cover.
3. Remove diaphragm and stem assembly. Check seat disc for debris and diaphragm for cuts or tears. Repair or replace as necessary.
4. Lubricate only sealing O-rings with Dow Corning FS 1292. **Do not** lubricate seat disc or diaphragm.
5. Reassemble and test.
